REMEDIAL INVESTIGATION WORK PLAN FOR PER- AND POLYFLUOROALKYL SUBSTANCES (PFAS)

FORMER FORT DEVENS ARMY INSTALLATION, DEVENS, MA

JUNE 2018

Prepared for:
U.S. Army Corps of Engineers
New England District
Concord, Massachusetts

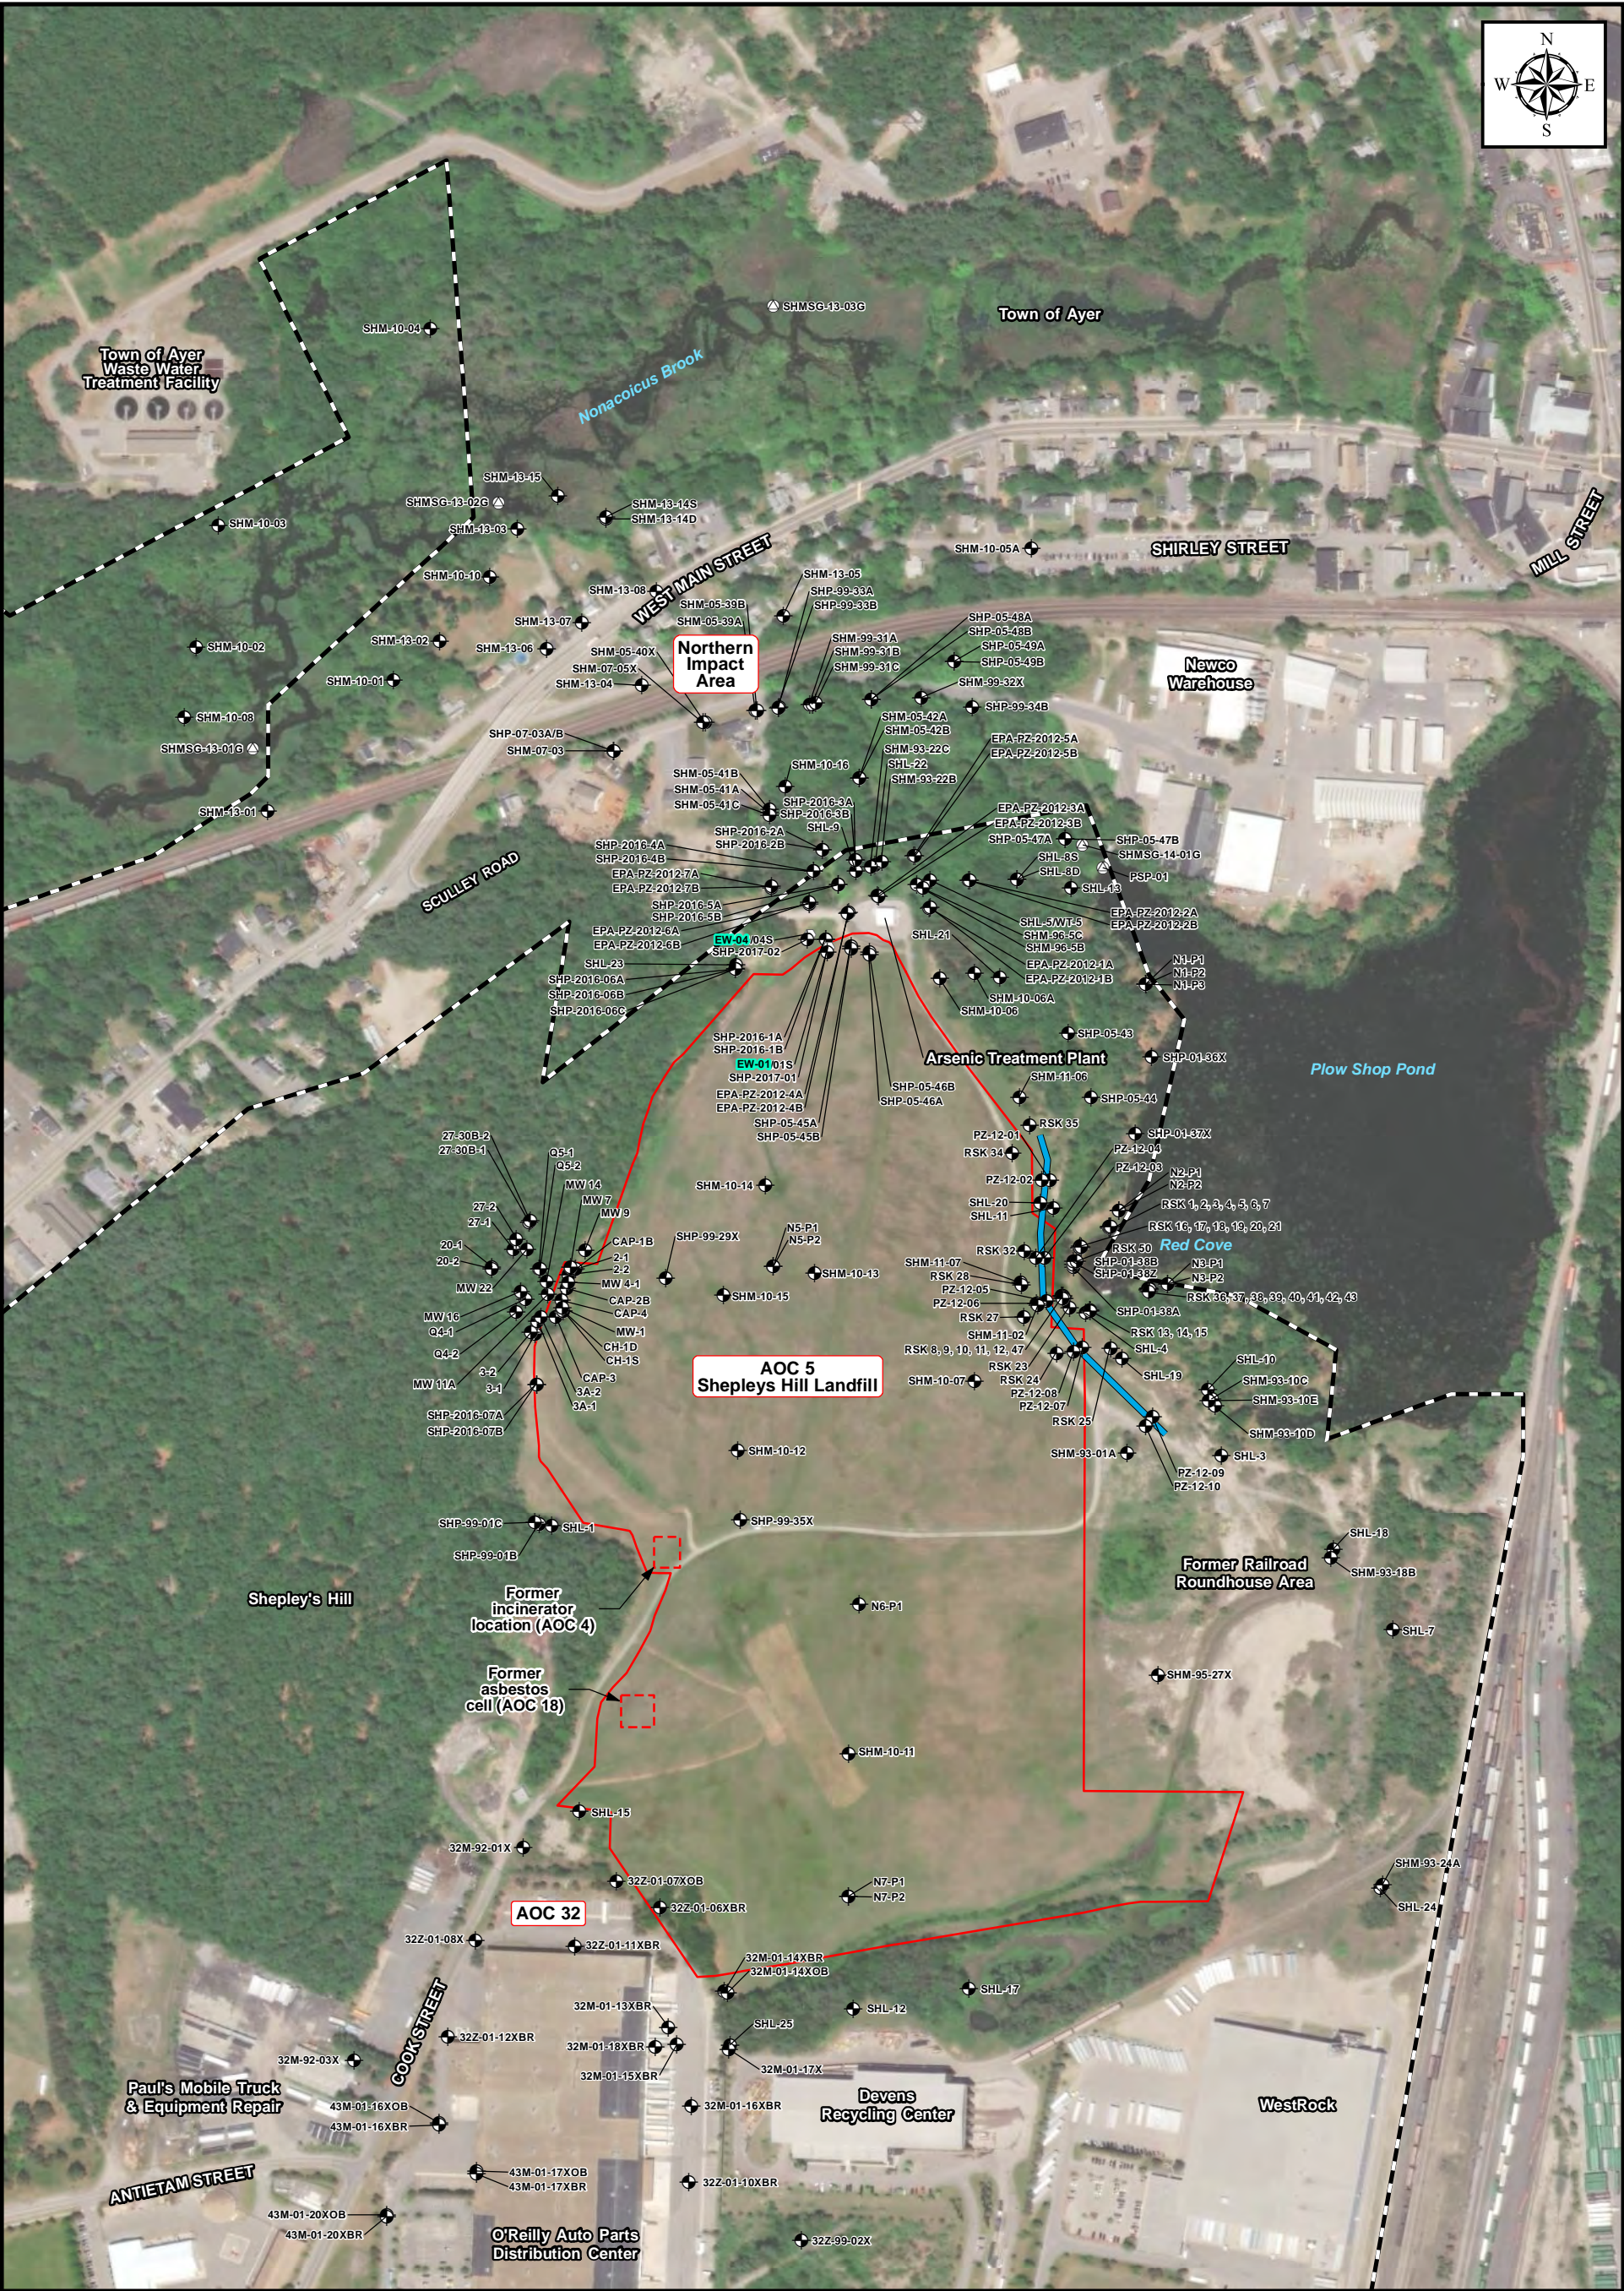
AOC 5 Site Layout
Devens PFAS Remedial Investigation Workplan

The Army began landfill operations in the 1940s, although test pit evidence indicates that earlier use as a landfill was highly probable (ANL, 1992). The landfill was in a former wetlands area and formerly operated as an open burning site (ANL, 1992). Landfill operations ceased as of July 1, 1992. The principal waste types in SHL include incinerator ash, household refuse, glass, construction debris, asbestos-containing materials, and spent shell casings. Army documentation indicates that no hazardous wastes were disposed of in SHL after November 19, 1980. The Massachusetts Department of Environmental Protection (MassDEP) approved the closure plan in 1985 and the Army capped the landfill in accordance with Massachusetts Regulations 310 CMR 19.000. The landfill was closed in five phases between 1986 and 1993 and was capped with a 30 to 40-mil polyvinyl chloride (PVC) membrane and overlying soil cover. In 2006, the Army commenced operation of a groundwater extraction and treatment system to address arsenic contamination in groundwater emanating from the landfill toward the NIA. Two extraction wells and the treatment plant were constructed at the north (downgradient) end of the landfill. It was later determined that the landfill cap and groundwater extraction system did not eliminate groundwater flow and arsenic migration from SHL into Red Cove at Plow Shop Pond. In 2012, the Army installed a low permeable groundwater barrier wall through the overburden to the

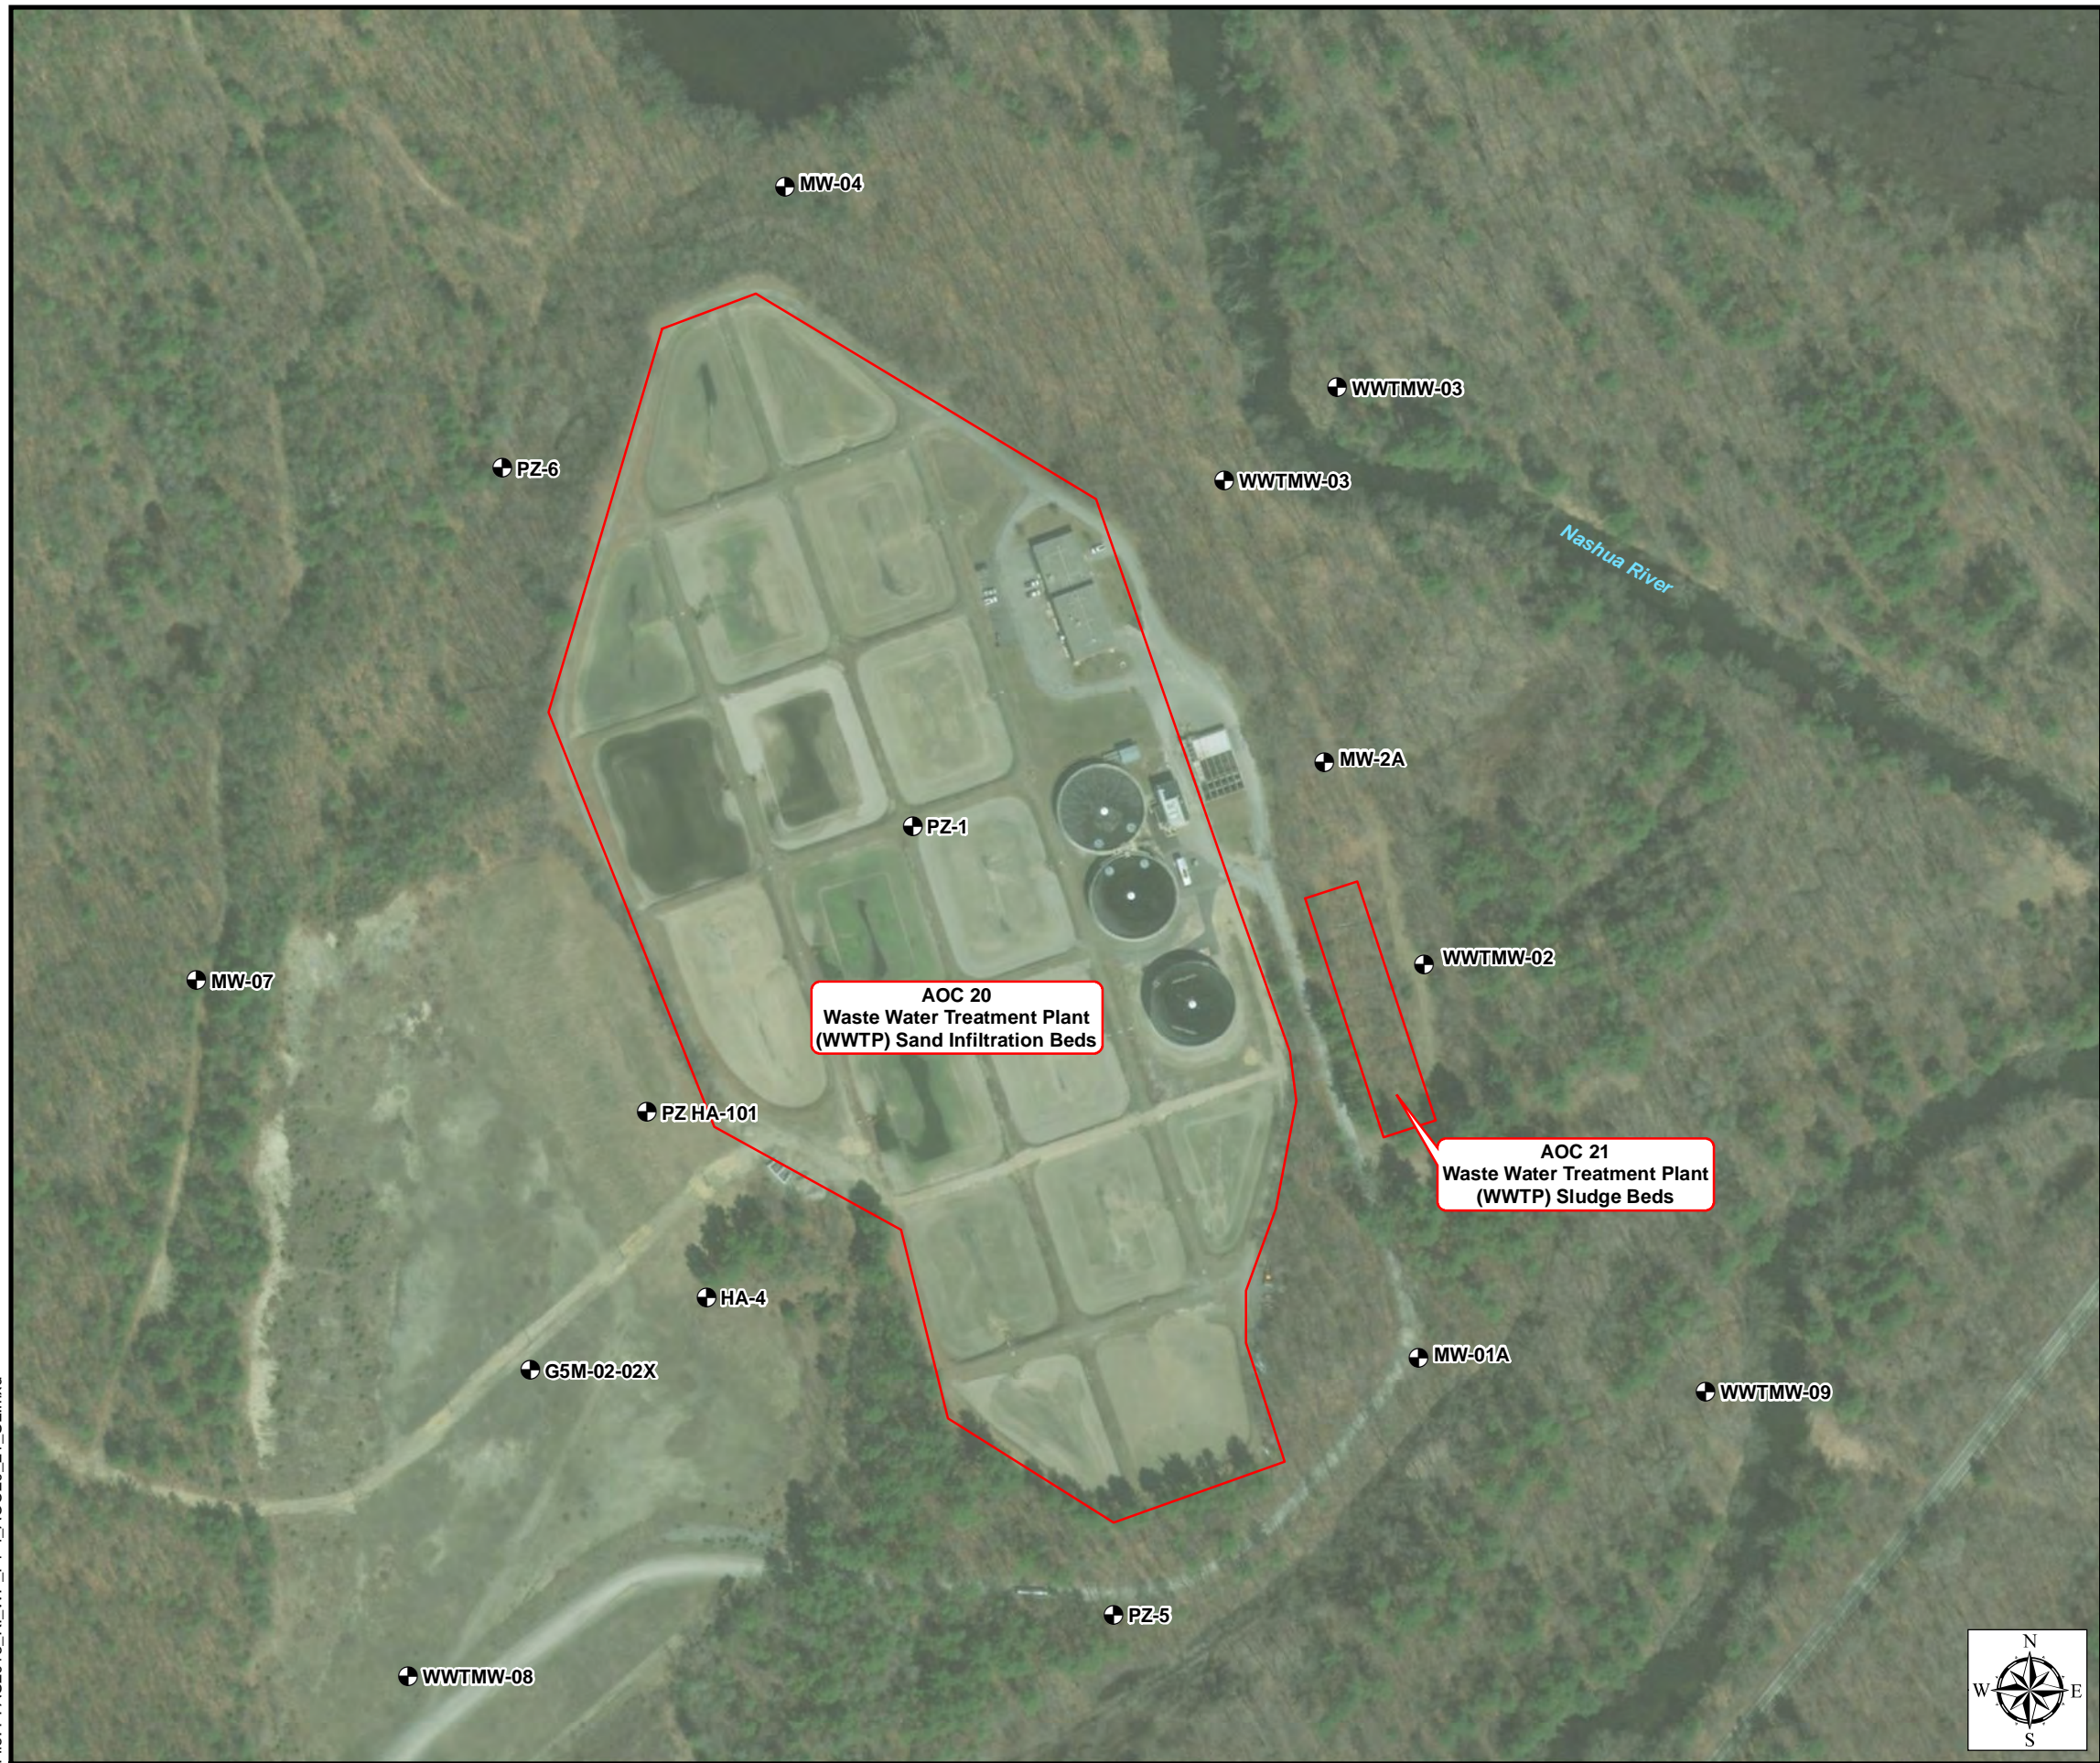
- Monitoring Well Location
- Area of Contamination (AOC)

The Devens Waste Water Treatment Plant (WWTP) is located in the former North Post area southwest of the Nashua River and former Moore Army Airfield (MAAF) (Figures 1-2 and 1-4). The WWTP was constructed by the Army in 1942 and is still in operation by MassDevelopment. Three components of the WWTP were initially identified as Study Areas: Imhoff tanks (SA 19), rapid infiltration beds (SA 20), and sludge drying beds (SA 21) (ANL, 1992) (ABB, 1993a).

three parallel Imhoff tanks (settling tanks and sludge digestors), a dosing tank, 22 rapid infiltration sand beds (0.8 acre each), and four sludge drying beds. The primary effluent from the Imhoff tanks discharges into a dosing tank, which intermittently applies wastewater to rapid infiltration basins. The infiltration basins are used in rotation. The application cycle involves discharge to nine basins for nine days, to another seven basins for seven days, and to the remaining six basins for six days (KGS, 2017c). The application rate for each rapid infiltration basin was calculated to be about 25-28 meters per year (ANL, 1992) (KGS, 2017c). Sludge from the Imhoff tanks is drained to four uncovered sludge drying beds two to three times annually. The sludge drying beds were equipped with 4-, 8-, and 10-inch clay pipe underdrains to collect supernatant. Before 1982, the supernatant was discharged to an adjacent wetland area located on the east bank of the Nashua River. After 1985, supernatant was collected and pumped back into an infiltration basin. Because these pipes have collapsed over the years and the sludge drying beds are located on the kame deposit, it is likely that most of the supernatant infiltrates into the permeable subsurface. In the past, dried sludge, typically about 70 percent solids, from the sludge drying beds was removed and applied to the land at the former MAAF per the requirements of a state Class EH Sludge application permit. Land application of dried sludge from the sludge drying beds at the former MAAF is no longer conducted (ANL, 1992, ABB, 1993a). The WWTP has been upgraded to provide advanced treatment (secondary treatment, nitrogen removal, and disinfection) through sequence batch reactors and ultraviolet disinfections (Nashua River Watershed Association, 2018). The WWTF is designed to treat 3 mgd of wastewater and is operated under a MassDEP groundwater discharge permit. The upgraded WWTF has been in operation since September 2001 and treats less than 1 mgd of wastewater from Devens and the Massachusetts Correctional Institution in Shirley. The treated effluent is discharged to the groundwater via rapid infiltration beds (Nashua River Watershed Association, 2018).

Wells have been installed at the site for past investigations and/or monitoring. Twenty observation wells were installed in 1974. These wells, which are no longer in use, provided data on water elevation and effectiveness of the infiltration beds (KGS, 2017c ANL, 1992). The 1992 Enhanced Preliminary Assessment (Weston, 1992) noted that the “current” monitoring well network consists of 16 wells. Wells 1 through 4 were installed in 1984, and wells 1a and 2a were installed in 1988. Wells 5 through 14 were installed in 1991 (Weston, 1992). The groundwater is monitored through wells placed up and downgradient of the discharge. The Nashua River is also monitored six times per year upstream and downstream of the discharge, and no noticeable impact to the river has been reported (Nashua River Watershed Association, 2018).

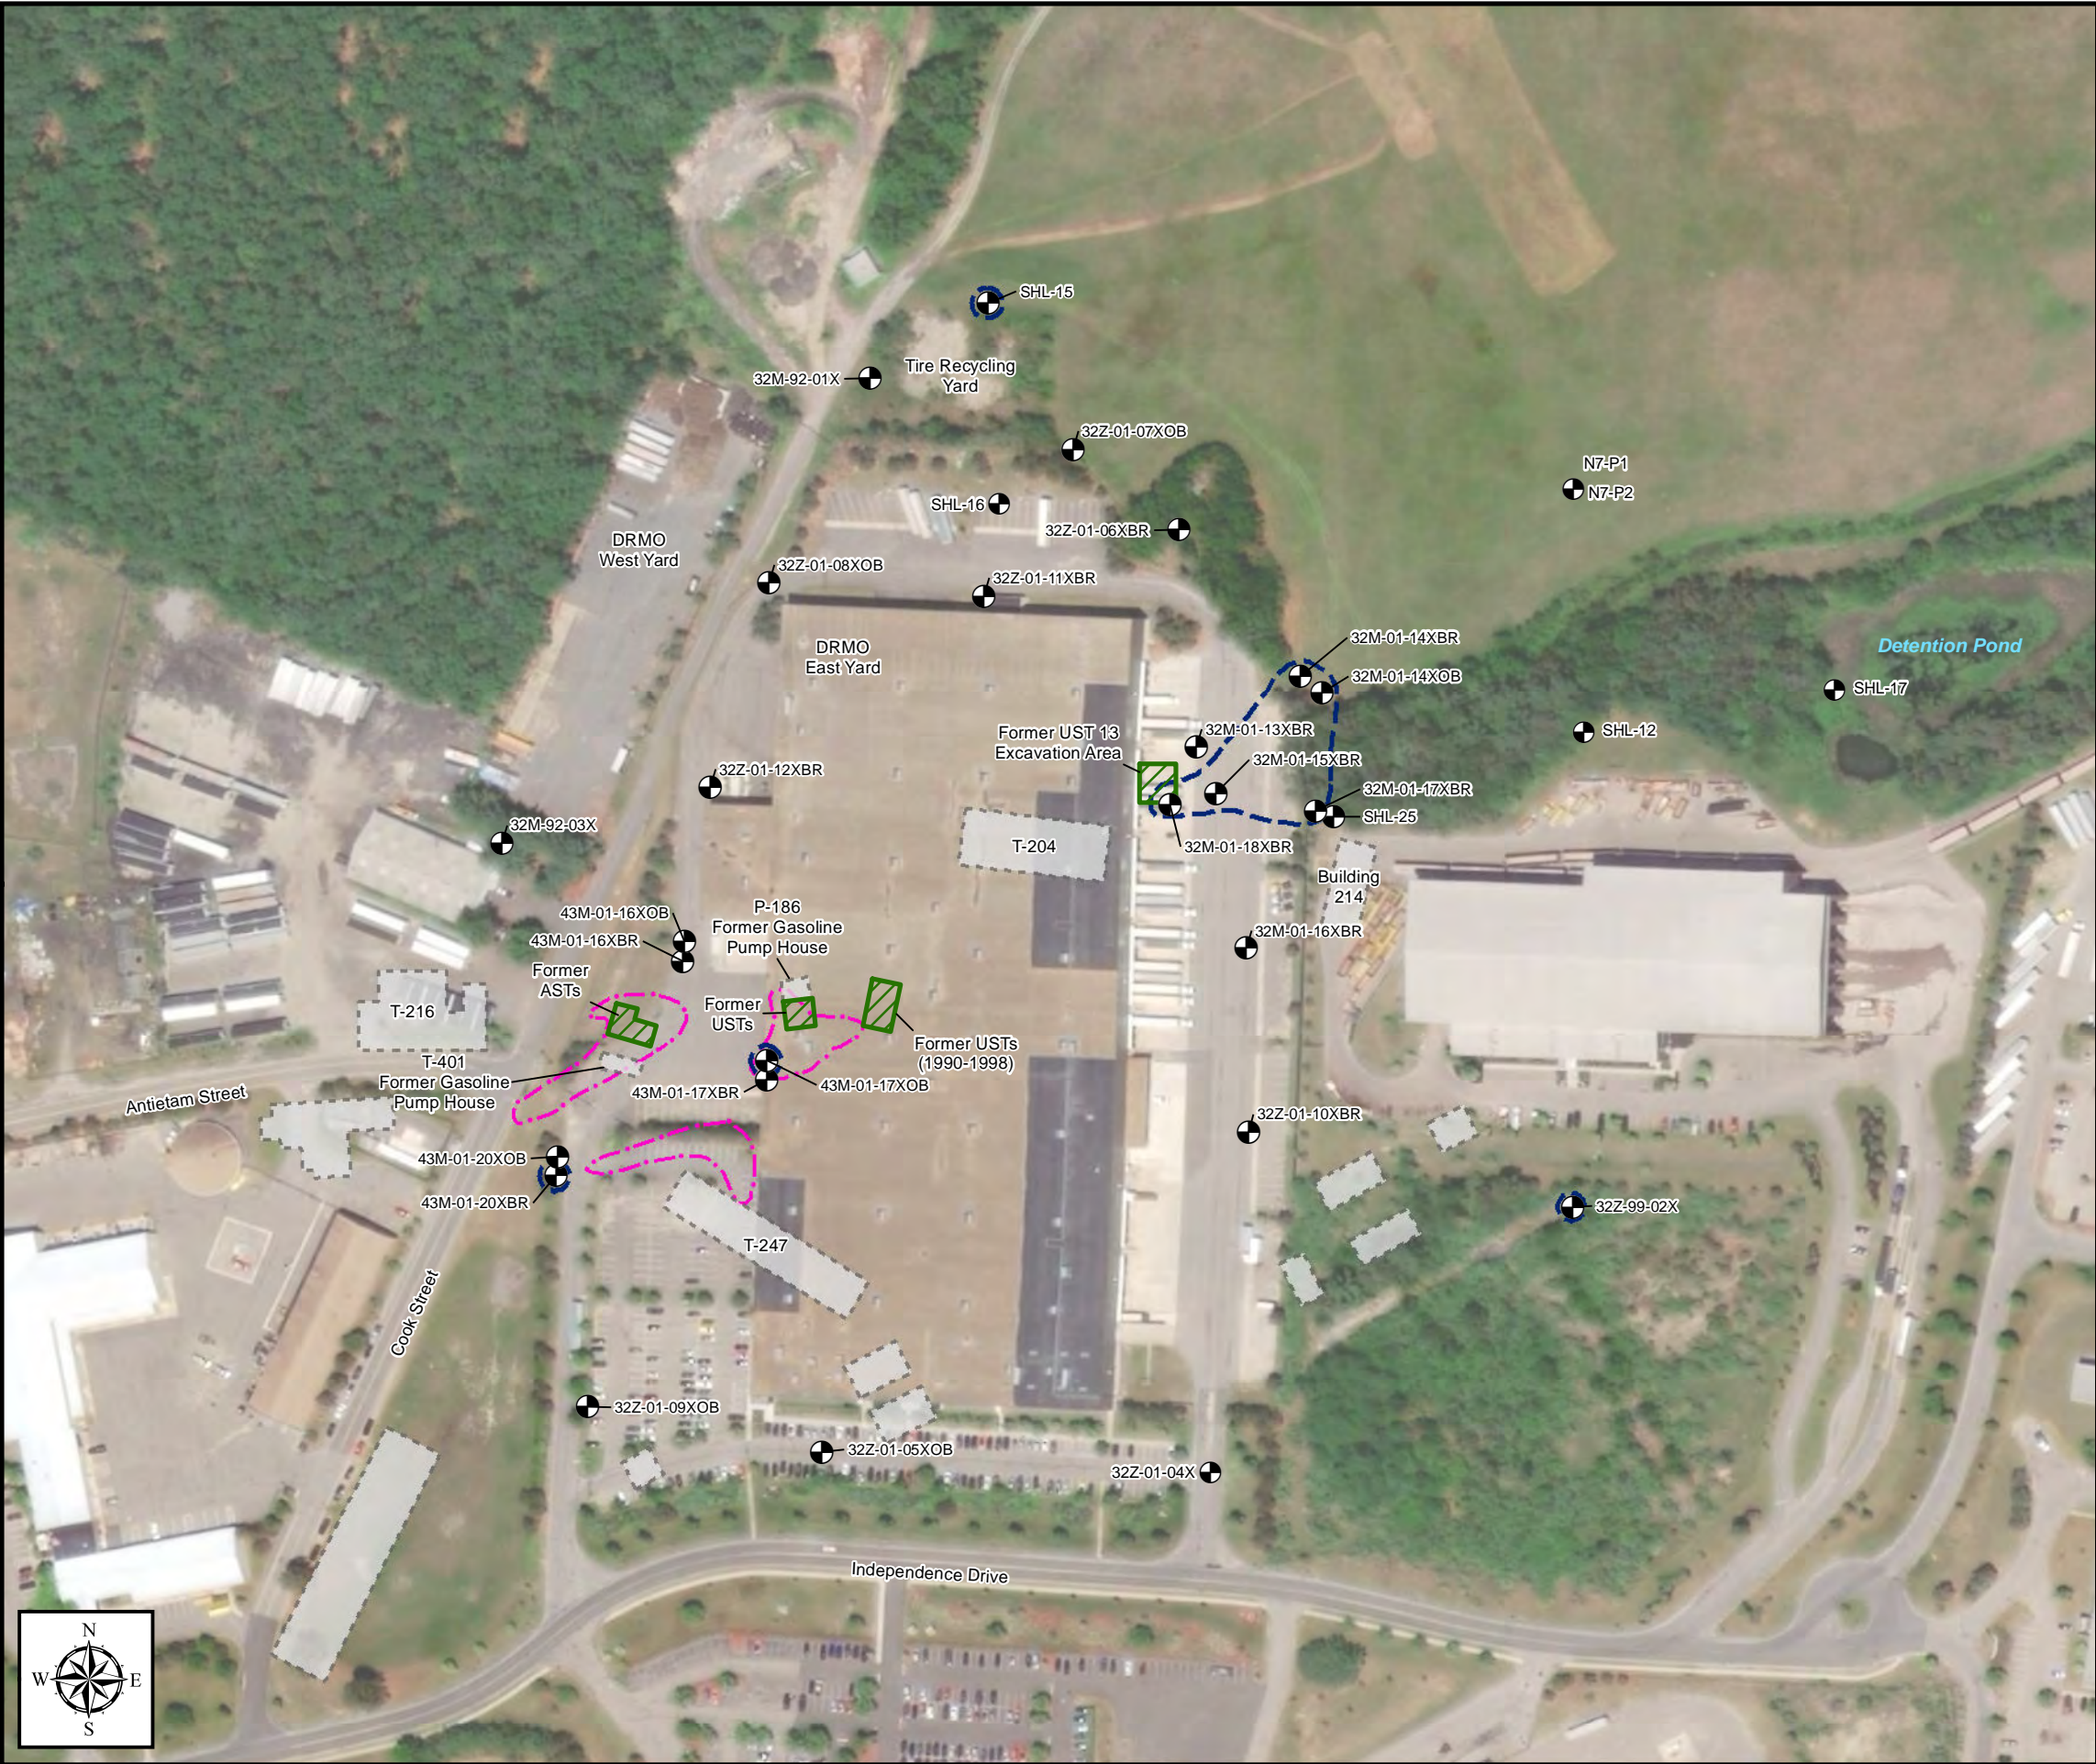
Figure
1-5

AOC 50 is at the former MAAF located within the former North Post (Figures 1-2 and 1-5). The former MAAF was used for military purposes and the main portion consisted of two fixed wing runways, two rotary wing runways, a parking area for 15 rotary-wing aircraft, and aircraft hangar (Building 3816) (Figures 1-5, 1-10). The northern part of the former MAAF, along Route 2A/Fitchburg Road, was used for the maintenance and storage of parachutes and former fueling systems were in this area (Figure 1-11).

The former MAAF Fire Station was located in former Building T-3806 (Figure 1-11). Interviews conducted with the Devens Fire Chief indicated firefighting foam concentrate was stored in 5-gallon pails on the fire apparatus. Foam concentrate was stored in 55-gallon drums at the drum storage area (AOC 30) (Figure 1-5). The former fire station was not identified as potential release area; however, PFAS may have been stored at the former airfield hangar area during the operational period of the Fort Devens airfield (KGS, 2017c).

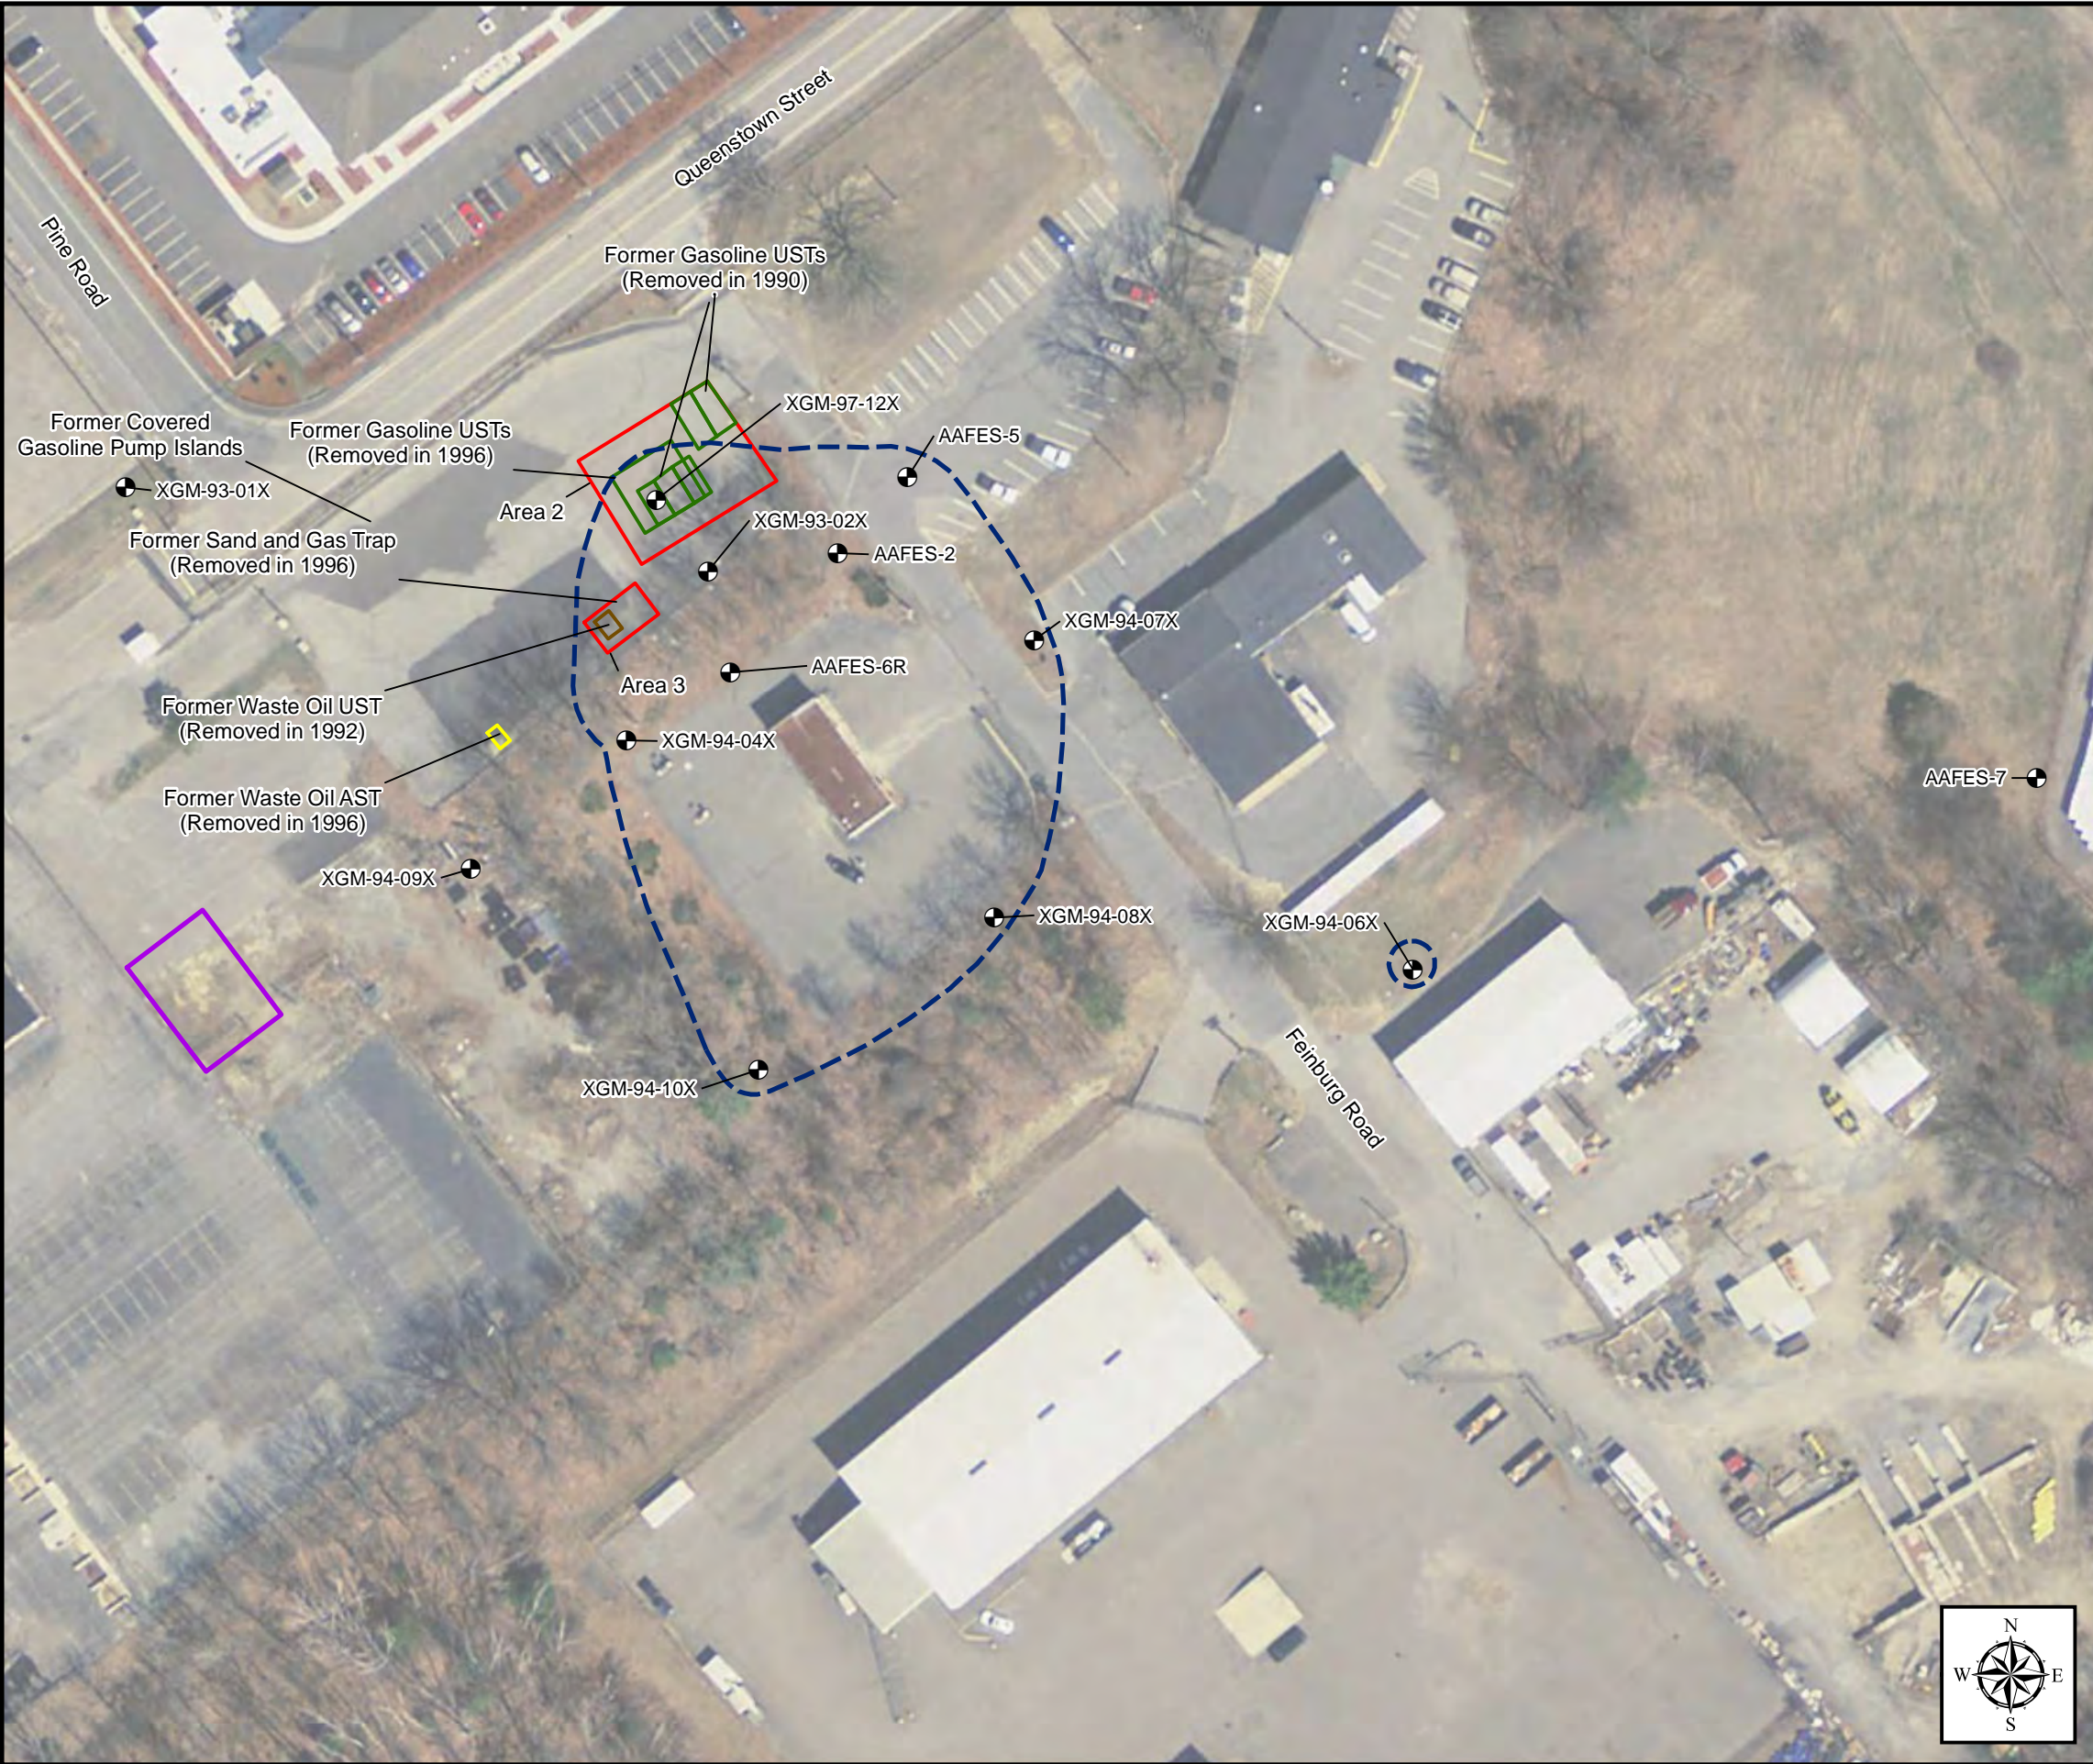
AOC 43G Site Layout Devens PFAS Remedial Investigation Workplan			
Former Fort Devens Army Installation Devens, Massachusetts			
KOMAN Government Solutions, LLC 293 Boston Post Road West, Suite 100, Marlborough, MA 01752			
0 40 80 Feet	Date: 06/05/2018	Figure 1-8

Based on the results of the 1992 and 1993 SI, supplemental SI (SSI), and revised human health Preliminary Risk Evaluation associated with the SSI, no further action was recommended for Area 1 (historical gas station G) (ABB, 1996a). The Army and USEPA signed a ROD in 1996 documenting the selection of intrinsic remediation with long-term monitoring (LTM) as the selected remedy. The major components of the selected remedy included intrinsic bioremediation, intrinsic bioremediation assessment data collection and groundwater modeling, installing additional monitoring wells, long-term groundwater monitoring, annual data reports to USEPA and MassDEP, and 5-year reviews. Intrinsic bioremediation is the principal component proposed to prevent COCs that exceed groundwater cleanup levels from potentially migrating off Army property (ABB, 1996e, Sovereign/HGL, 2015).

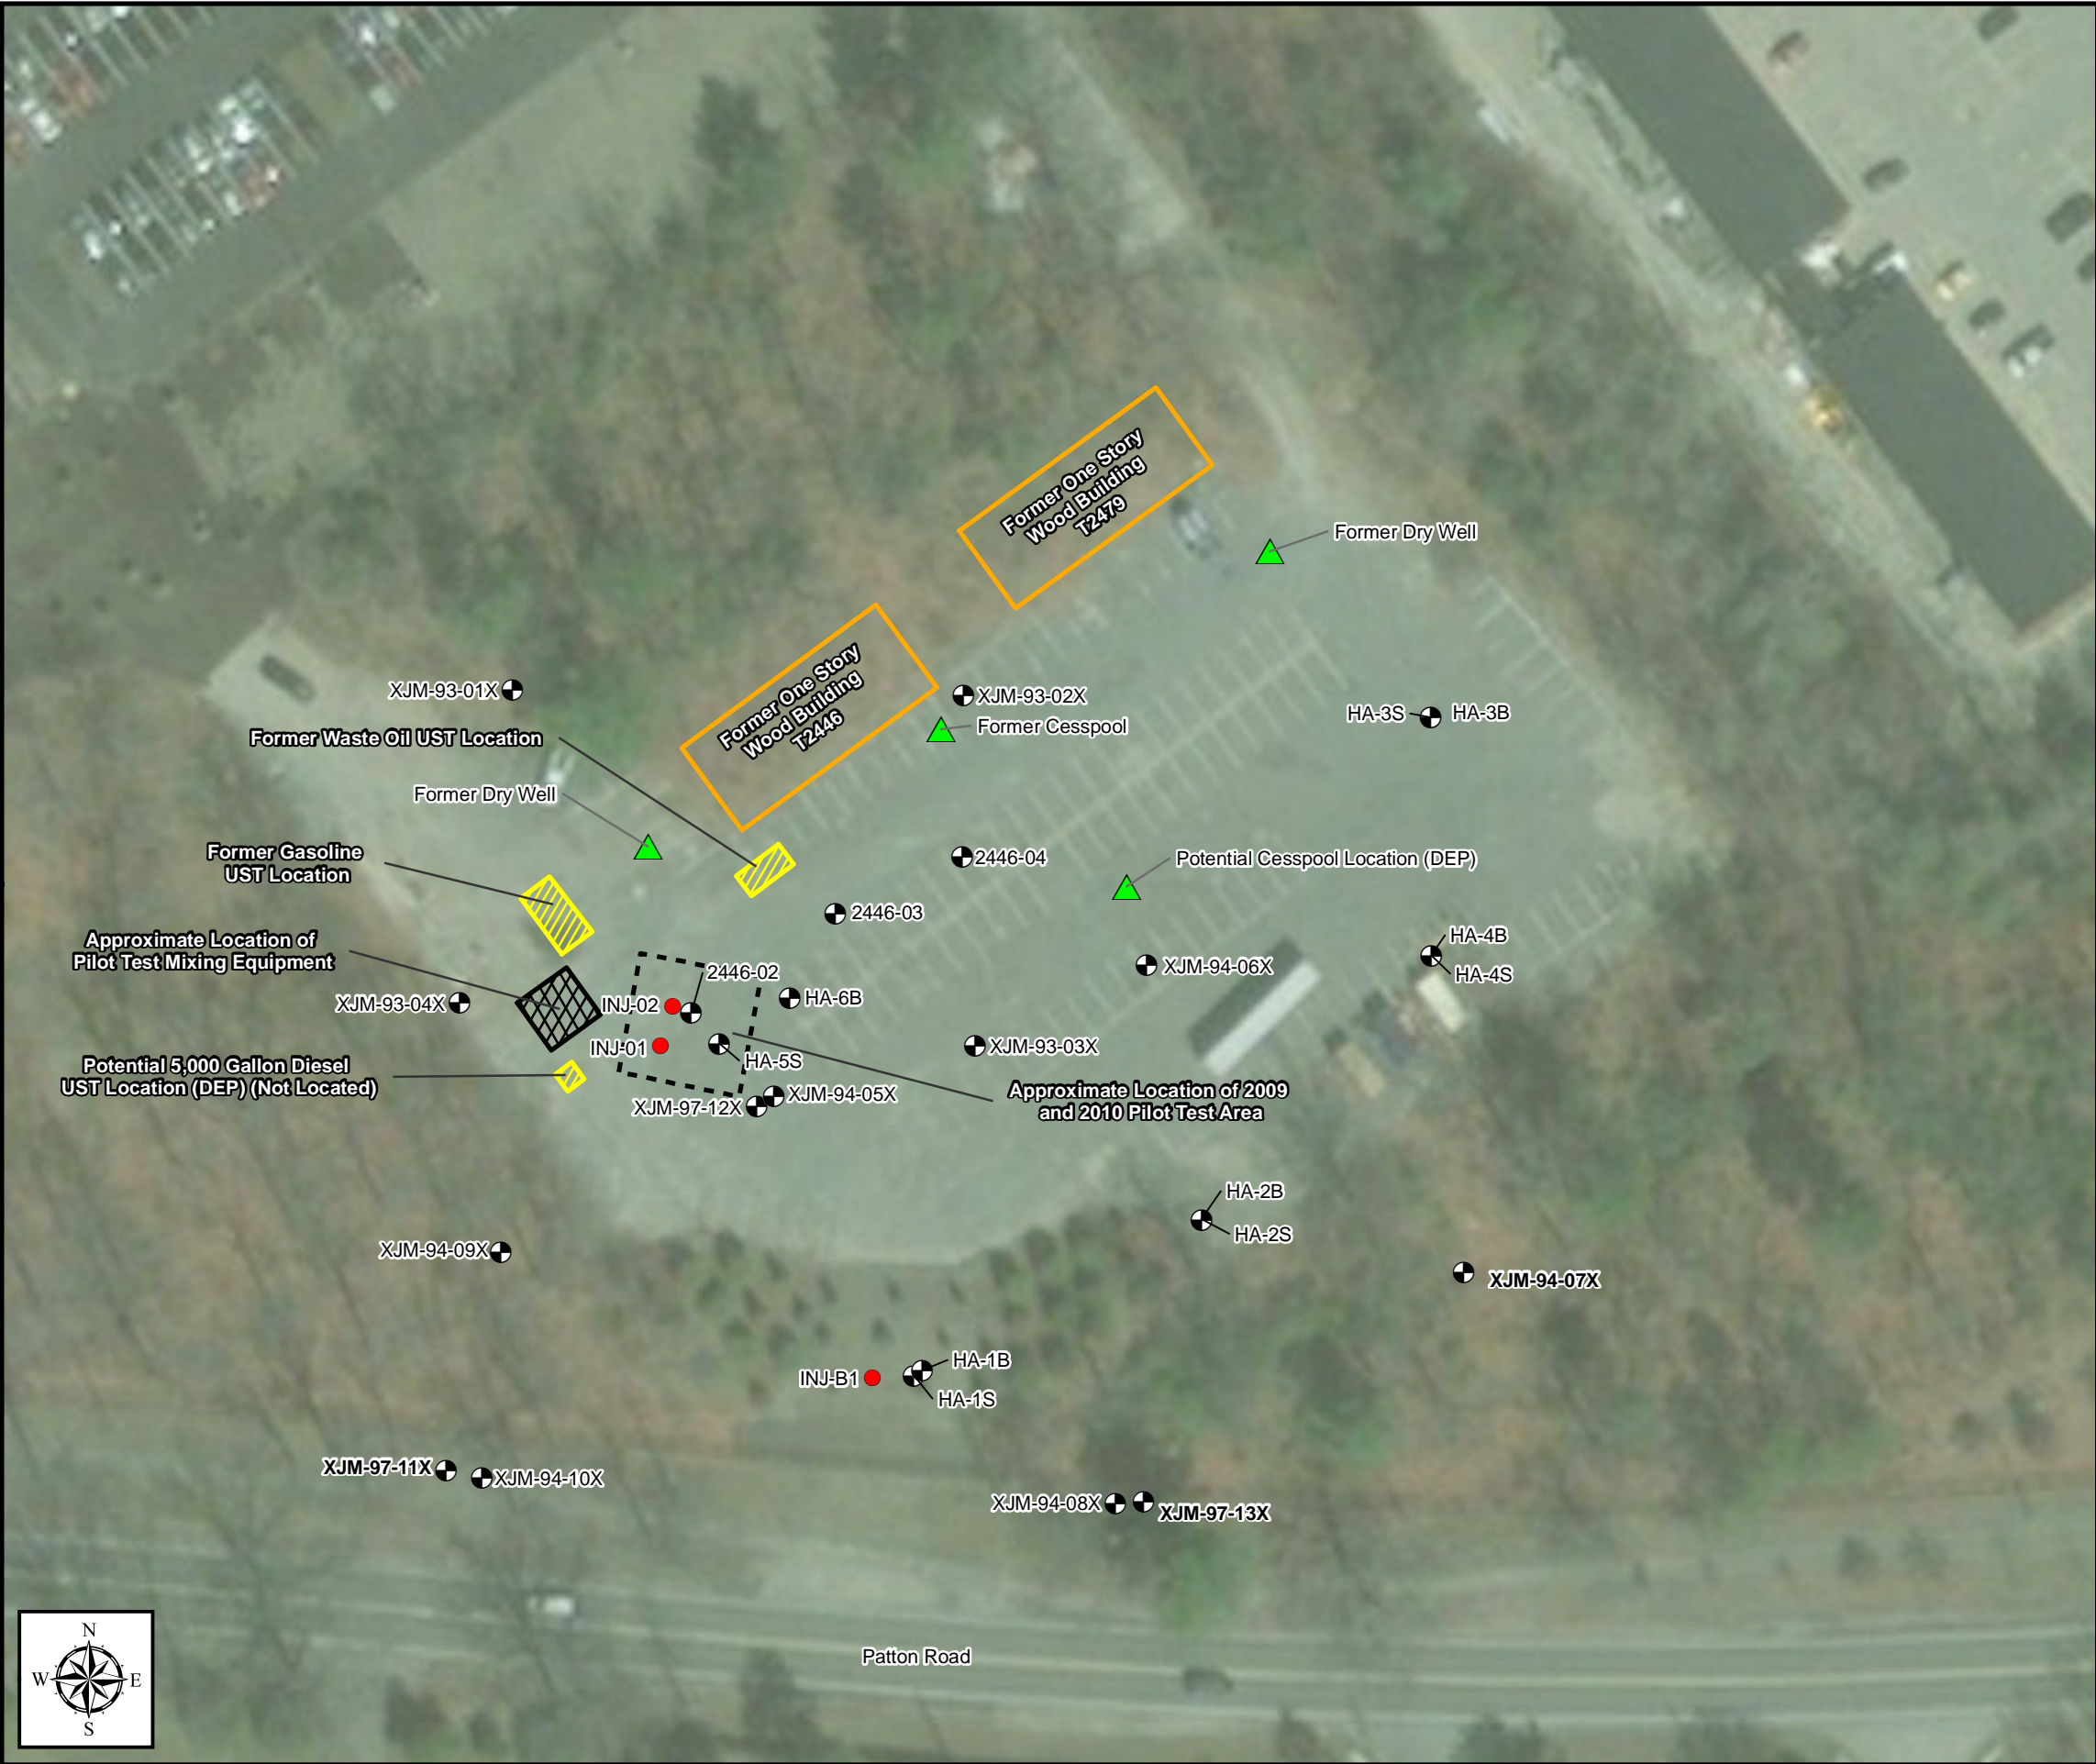
- Legend
- ▲ Approximate Location of Potential Former Source Area Investigated
 - Monitoring Well
 - Injection Well
 - ▨ Approximate Location of Former UST
 - ⋯ Approximate Location of 2009 and 2010 Pilot Test Area
 - ▩ Approximate Location of Pilot Test Mixing Equipment
 - Former Building

AOC 43J Site Layout Devens PFAS Remedial Investigation Workplan			
Former Fort Devens Army Installation Devens, Massachusetts			
KOMAN Government Solutions, LLC 293 Boston Post Road West, Suite 100, Marlborough, MA 01752			
0 30 60 Feet	Date: 06/05/2018	Figure 1-9

AOC 43J was first identified as a possible source of contamination in 1988 (ANL, 1992). The Army identified several leaking USTs which held gasoline, waste oil, and diesel. At the time of base closure in 1996, the area around AOC 43J was used as a vehicle storage yard and maintenance facility (former Buildings T-2446 and T-2479) for a Special Forces Unit of the Army. The former maintenance facility used a 1,000-gallon UST for storage of maintenance wastes. This UST was located just south of former Building T-2446 (Haley and Aldrich, 2017).

During the 1992 SI, an abandoned 5,000-gallon UST was found in the area of the historical gas station J. This UST was added to the Devens UST removal program and removed in August 1992. The former waste oil UST was also removed during May of the same year. During both UST removals, contaminated impacted soil was removed and disposed of by the Army. Based on the data and the findings of the 1992 SI, additional investigation was recommended (ABB, 1996d).

It was noted during a five-year review that MNA would not reach the ROD goals within the required 30-year performance period, and therefore subsequent pilot testing of remedial-amendment injections were performed using two separate pilot tests during 2010 and 2011 (Haley and Aldrich, 2015). These tests concluded that sodium persulfate/calcium peroxide would provide short-term oxidation and long-term reduction processes to augment MNA to reduce petroleum-related contaminant concentrations remaining at the site. Remedial-amendment injections of sodium persulfate/calcium peroxide were performed during 2012 and subsequent groundwater sampling conducted in 2013 and 2014 indicated that BTEX concentrations had generally decreased over time in most monitoring wells; however, continued monitoring was recommended (Haley and Aldrich, 2015 and 2017).
